## MANAGEMENT ASBESTOS SURVEY REPORT

**Site Name:** 45 Westbourne Road  
**Site Address:** Marsh  
Huddersfield  
West Yorkshire  
HD1 4LG

**Date of Survey:** 13 March 2023

**Survey Type:** Management Survey

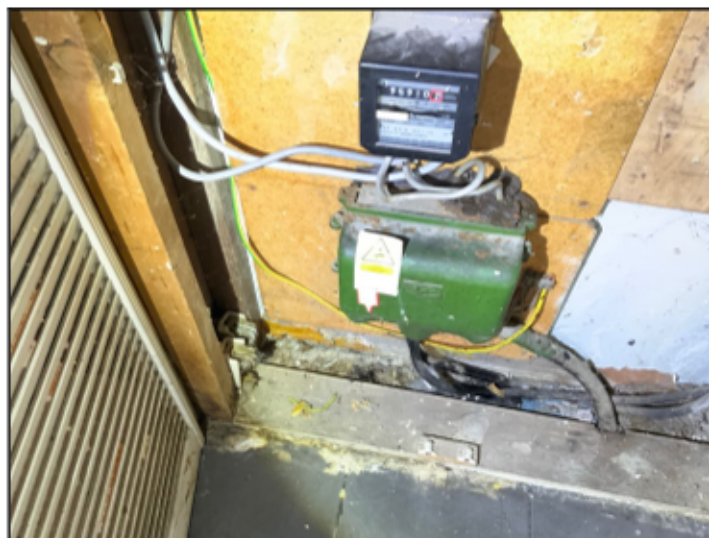
### MATERIAL ASSESSMENT = 6

<b>Material</b>	Internal Asbestos Materials (2)	<b>Surface Treatment</b>	Unsealed cement / Enclosed lagging or spray / Encapsulated board (1)
<b>Condition</b>	Good Condition (0)	<b>Sample Result</b>	<b>Crocidolite</b>
<b>Location</b>	Room(s) up to 100m <sup>2</sup>	<b>Amount</b>	
<b>Accessibility</b>	Easily Disturbed

**Recommendations** The electrical equipment appears to be in good condition and can remain in-situ if required. A management plan needs to be put in place to monitor the electrical equipment on a regular basis for any signs of deterioration or damage. Should any damage occur, then the electrical equipment should be removed complete without any disturbance to the internal materials by suitably trained persons under controlled conditions using HSE Guidelines, and be disposed of at a licensed disposal facility.

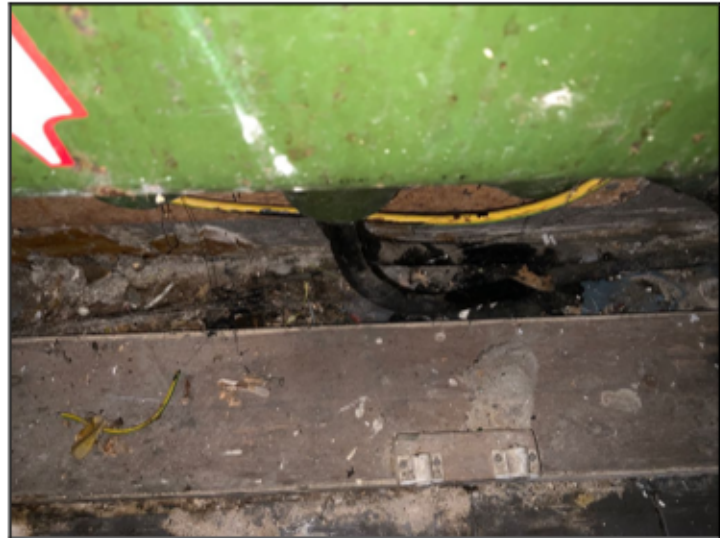
Action	Priority	Notifiable	Licensed
Additional Comments	No asbestos was identified within the sample analysed.		
Recommendations

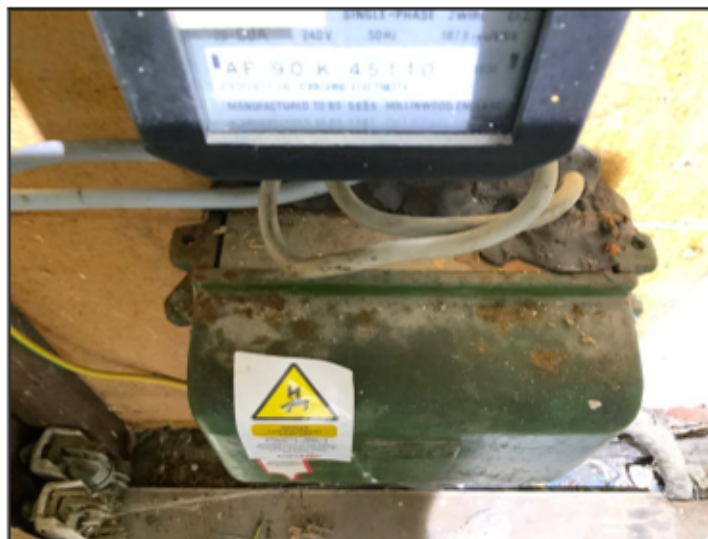
Action	Priority	Notifiable	Licensed
Additional Comments	No asbestos was identified within the sample analysed.		
Recommendations

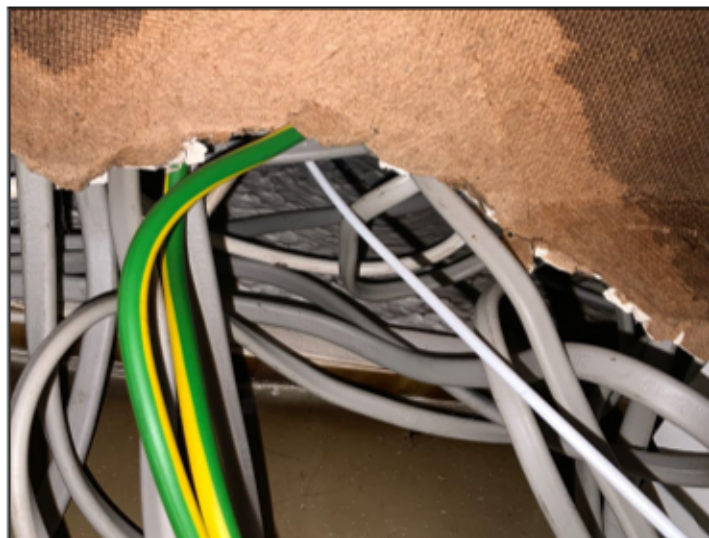
Action	Priority	Notifiable	Licensed
Additional Comments	No asbestos was identified within the sample analysed.		
Recommendations

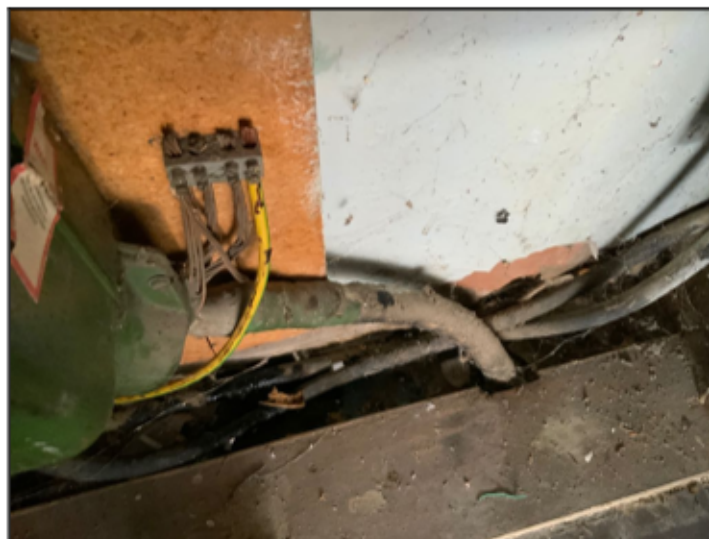
Action	Priority	Notifiable	Licensed
Additional Comments	No asbestos was identified within the sample analysed.		
Recommendations

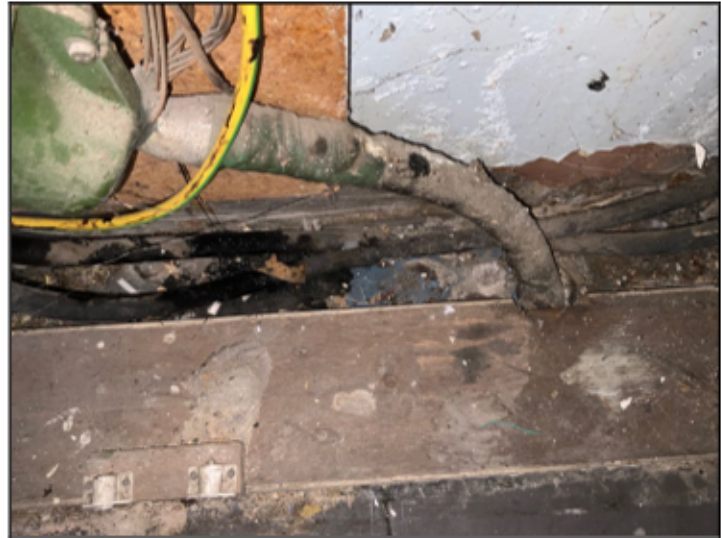
### MATERIAL ASSESSMENT = 3

Material	Vinyl Tiles (1)	Surface Treatment	Composite, reinforced or bonded (0)
Condition	Low Damage (1)	Sample Result	<b>Chrysotile</b>
Location	Room(s) up to 100m <sup>2</sup>	Amount	1 lin m
Accessibility	Occasional Disturbance

Building Unit	Floor	Location	Item Description	Recommendations
45 Westbourne Road	0 (Ground)	003 - Electrical Cupboard	Floor Tiles & Adhesive - Vinyl Tiles	<b>MANAGE (FLOOR TILES &amp; ADHESIVE)</b> - The floor tiles and bitumen adhesive do not represent a hazard whilst they remain undisturbed and therefore can remain in-situ if required. A management plan needs to be put in place and the floor tiles and the adhesive regularly monitored for any signs of deterioration or damage. Should any damage occur, then removal by suitably trained persons using H.S.E guidelines should be considered.
45 Westbourne Road	0 (Ground)	003 - Electrical Cupboard	Electrical Equipment - Internal Asbestos Materials	<b>MANAGE (ELECTRICAL EQUIPMENT)</b> - The electrical equipment appears to be in good condition and can remain in-situ if required. A management plan needs to be put in place to monitor the electrical equipment on a regular basis for any signs of deterioration or damage. Should any damage occur, then the electrical equipment should be removed complete without any disturbance to the internal materials by suitably trained persons under controlled conditions using HSE Guidelines, and be disposed of at a licensed disposal facility.

**The floor tiles and bitumen adhesive do not represent a hazard whilst they remain undisturbed and therefore can remain in-situ if required. A management plan needs to be put in place and the floor tiles and the adhesive regularly monitored for any signs of deterioration or damage. Should any damage occur, then removal by suitably trained persons using H.S.E guidelines should be considered.**

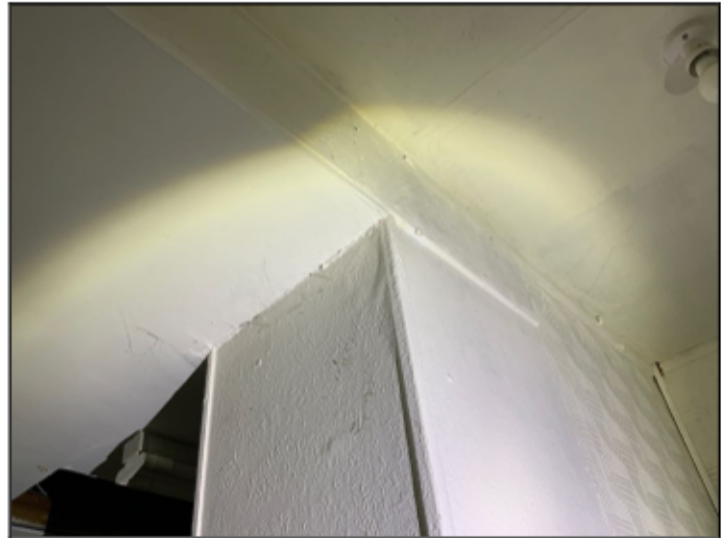
Action	Priority	Notifiable	Licensed
Additional Comments	<b>No asbestos was identified within the sample analysed.</b>		
Recommendations

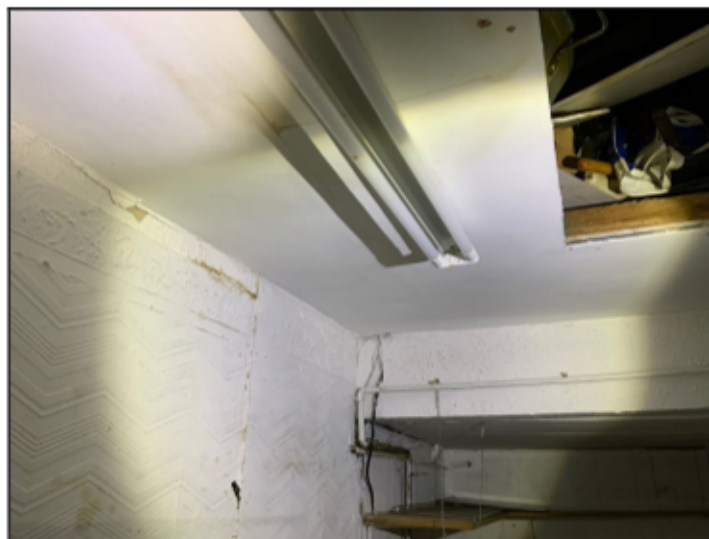
Action	Priority	Notifiable	Licensed
Additional Comments	<b>No asbestos was identified within the sample analysed.</b>		
Recommendations

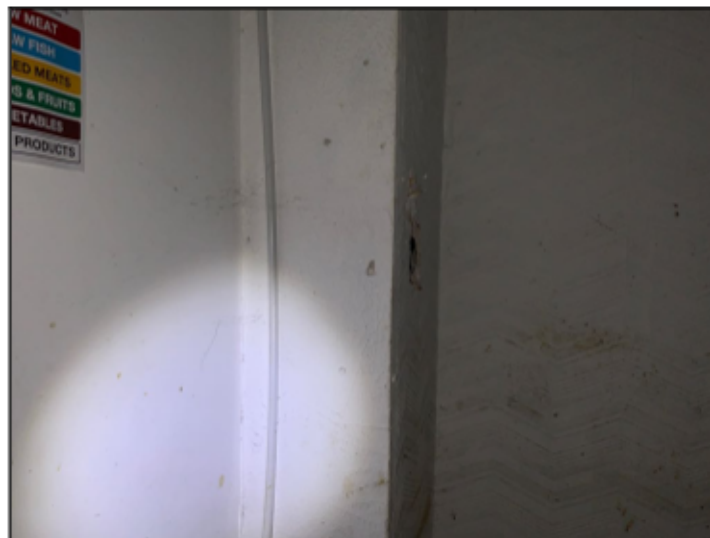
Action	Priority	Notifiable	Licensed
Additional Comments	No asbestos was identified within the sample analysed.		
Recommendations

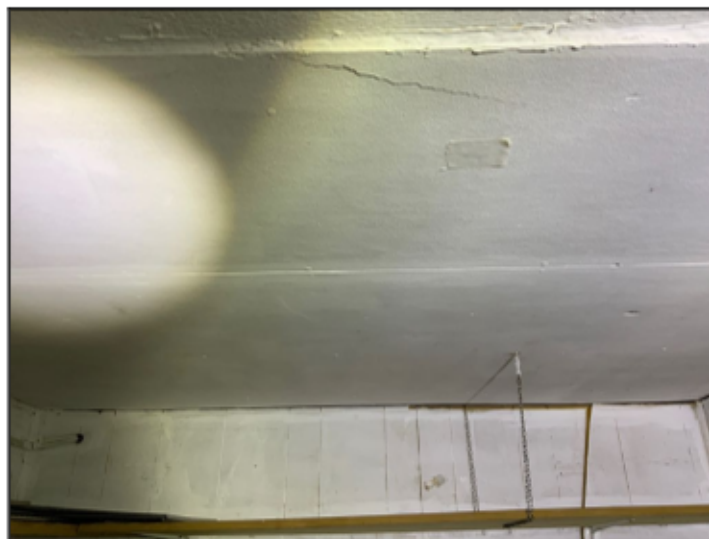
### MATERIAL ASSESSMENT = 6

<b>Material</b>	Insulating Board (2)	<b>Surface Treatment</b>	Unsealed cement / Enclosed lagging or spray / Encapsulated board (1)
<b>Condition</b>	Low Damage (1)	<b>Sample Result</b>	<b>Amosite/Chrysotile</b>
<b>Location</b>	Room(s) up to 100m <sup>2</sup>	<b>Amount</b>	4 m <sup>2</sup>
<b>Accessibility</b>	Occasional Disturbance

45 Westbourne Road	0 (Ground)	006 - Store	Ceiling Boards - Insulating Board	<b>ENCAPSULATE/ MANAGE/ LABEL (AIB)</b> - The boards are in a damaged condition. They need to be repaired and encapsulated by a licensed removal company. A management plan should then be put in place to monitor the boards on a regular basis for any signs of further deterioration or damage. Should any further damage occur then the boards will need to be repaired or removed by a licensed removal company as a priority. Labelling of the boards left in-situ is also recommended.

**The boards are in a damaged condition. They need to be repaired and encapsulated by a licensed removal company. A management plan should then be put in place to monitor the boards on a regular basis for any signs of further deterioration or damage. Should any further damage occur then the boards will need to be repaired or removed by a licensed removal company as a priority. Labelling of the boards left in-situ is also recommended.**

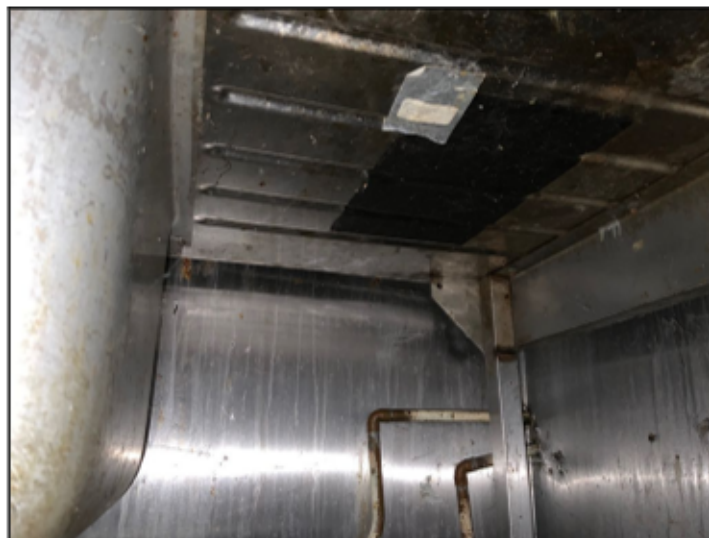
Action	Priority	Notifiable	Licensed
Additional Comments	No asbestos was identified within the sample analysed.		
Recommendations

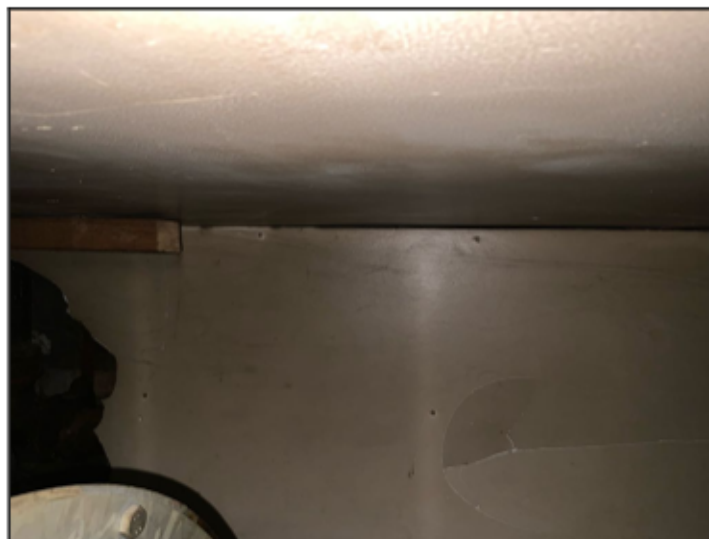
### MATERIAL ASSESSMENT = 10

<b>Material</b>	Insulating Board (2)	<b>Surface Treatment</b>	Unsealed lagging or spray (3)
<b>Condition</b>	High Damage (3)	<b>Sample Result</b>	<b>Amosite/Chrysotile</b>
<b>Location</b>	Confined Space	<b>Amount</b>	8 m <sup>2</sup>
<b>Accessibility</b>	Occasional Disturbance

**Recommendations** **The boards are in a poor condition and need to be removed by a licensed removal company as a priority.**

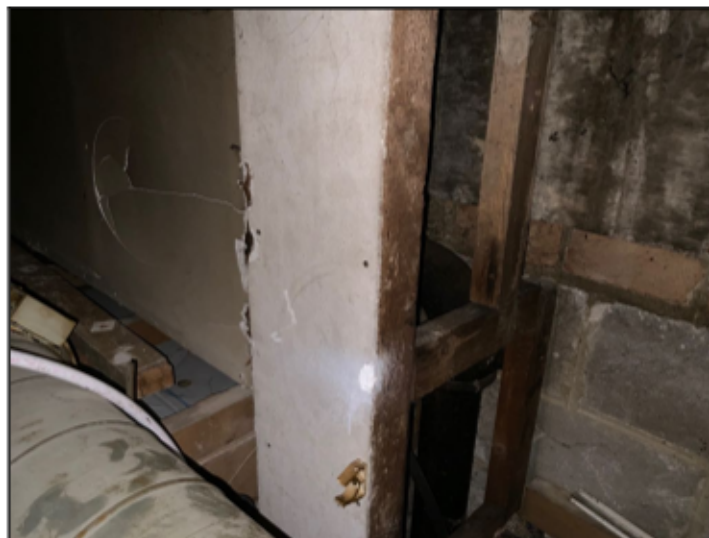
### MATERIAL ASSESSMENT = 10

<b>Material</b>	Insulating Board (2)	<b>Surface Treatment</b>	Unsealed lagging or spray (3)
<b>Condition</b>	High Damage (3)	<b>Sample Result</b>	<b>Amosite/Chrysotile</b>
<b>Location</b>	Confined Space	<b>Amount</b>	2 lin m
<b>Accessibility</b>	Occasional Disturbance

<b>Action</b>	<b>REMOVE (AIB)</b>	<b>Priority</b>	<b>1</b>	<b>Notifiable</b>	<b>Yes</b>	<b>Licensed</b>	<b>Yes</b>
<b>Additional Comments</b>							
<b>Recommendations</b>	<b>The board is in a poor condition and needs to be removed by a licensed removal company as a priority</b>

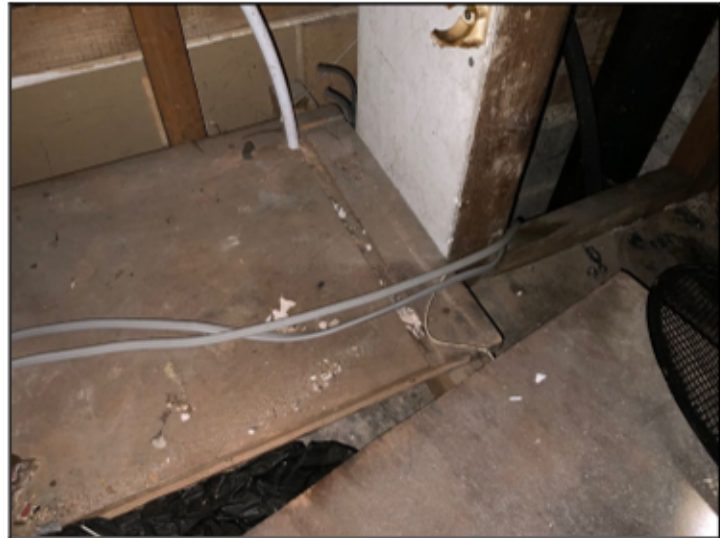
### MATERIAL ASSESSMENT = 10

Material	Insulating Board (2)	Surface Treatment	Unsealed lagging or spray (3)
Condition	High Damage (3)	Sample Result	<b>Amosite/Chrysotile</b>
Location	Confined Space	Amount	
Accessibility	Easily Disturbed

Building / Unit	Floor	Location	Item Description	Recommendations
45 Westbourne Road	0 (Ground)	008 - Ceiling Void	Board Debris - Insulating Board	<b>REMOVE / ENVIRONMENTAL CLEAN (AIB DEBRIS)</b> - The insulation board debris needs to be removed and the area environmentally cleaned by a licensed removal company as a priority.
45 Westbourne Road	0 (Ground)	008 - Ceiling Void	Board forming Boxing - Insulating Board	<b>REMOVE (AIB)</b> - The board is in a poor condition and needs to be removed by a licensed removal company as a priority
45 Westbourne Road	0 (Ground)	008 - Ceiling Void	Wall Boards - Insulating Board	<b>REMOVE (AIB)</b> - The boards are in a poor condition and need to be removed by a licensed removal company as a priority.
45 Westbourne Road	0 (Ground)	009 - External	Putty Seals to Windows & Doors - Putty	<b>MANAGE (PUTTY)</b> - The putty is in good condition and can remain in-situ if required. A management plan needs to be put in place to monitor the putty on a regular basis for any signs of deterioration or damage. Should any damage occur then repair or removal by suitably trained persons should be considered.

Recommendations **The insulation board debris needs to be removed and the area environmentally cleaned by a licensed removal company as a priority.**

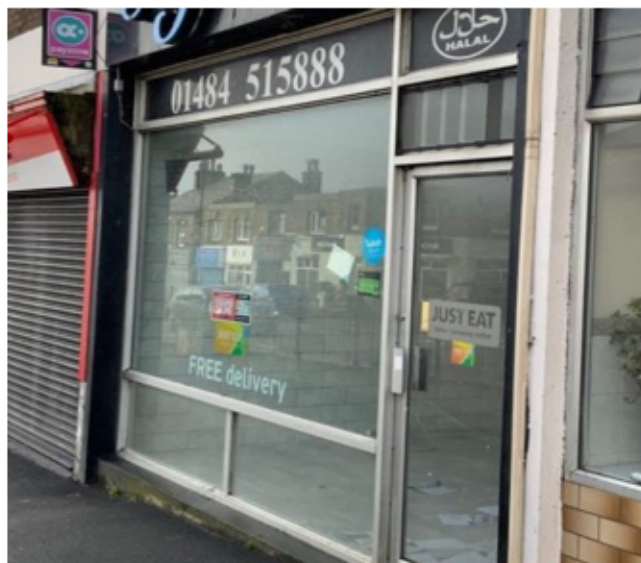
### MATERIAL ASSESSMENT = 2

Material	Putty (1)	Surface Treatment	Composite, reinforced or bonded (0)
Condition	Good Condition (0)	Sample Result	<b>Chrysotile</b>
Location	Outdoors	Amount	20 lin m
Accessibility	Occasional Disturbance

Recommendations **The putty is in good condition and can remain in-situ if required. A management plan needs to be put in place to monitor the putty on a regular basis for any signs of deterioration or damage. Should any damage occur then repair or removal by suitably trained persons should be considered.**

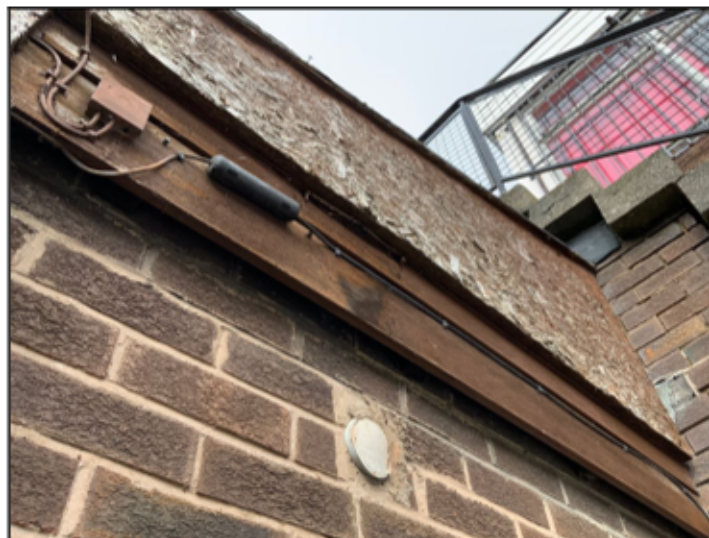
Action	Priority	Notifiable	Licensed
Additional Comments	No asbestos was identified within the sample analysed.		
Recommendations
